# ANNUAL REPORT FOR 2010

**Bald Creek Site #4 Mitigation Site  
Yancey County  
TIP No. R-2518B**

Prepared By:  
Natural Environment Unit & Roadside Environmental Unit  
North Carolina Department of Transportation  
December 2010

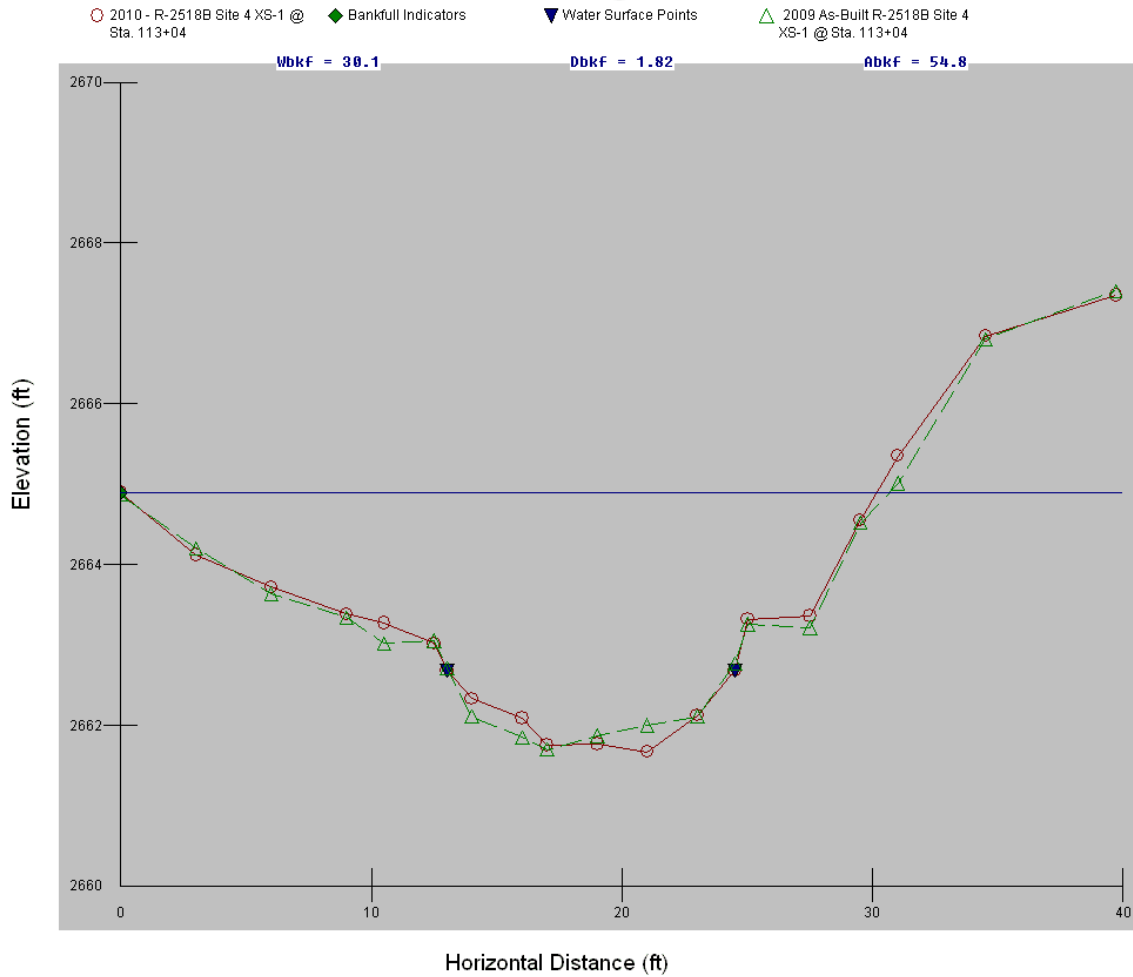
# R-2518B Site 4 XS-1 @ Sta. 113+04

Based on comparisons of the As-Built to Year 1 monitoring data, all of the cross sections appear stable with little or no active bank erosion. Graphs of the cross sections are presented in Appendix A. Future survey data will vary depending on actual location of rod placement and alignment; however, this information should remain similar in appearance. The longitudinal profile showed that the channel was stable for the 2010 monitoring evaluation. Pebble counts were not required per the permit conditions and therefore were not completed.

## Site #4: Cross-Section #1 (Pool) Abbreviated Morphological Summary\*

2010	2011	2012	2013	2014
Bankfull Cross Sectional Area (ft <sup>2</sup> )	54.78				
Maximum Bankfull Depth (ft)	3.22				
Bankfull Mean Depth (ft)	1.82				
Bankfull Width (ft)	30.14

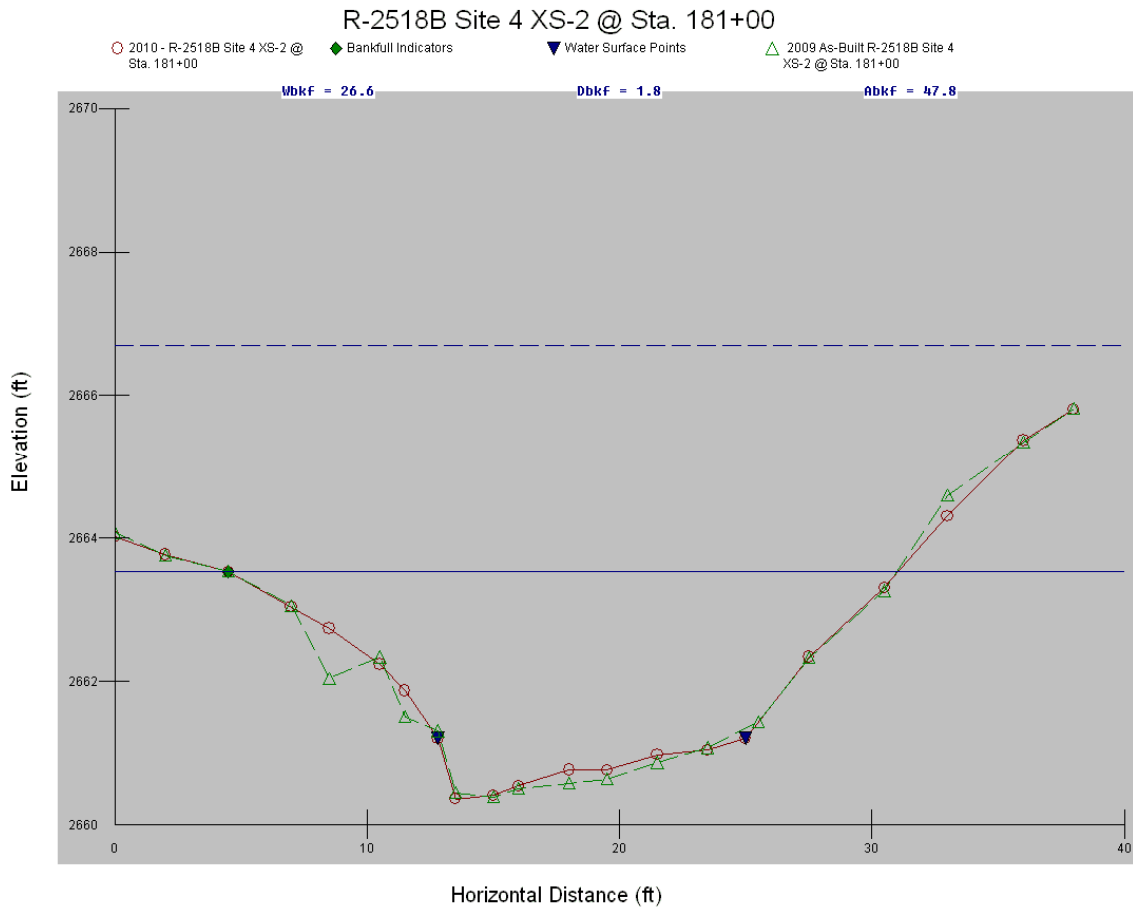
Site #4: Cross-Section #2 (Riffle) Abbreviated Morphological Summary					
	2010	2011	2012	2013	2014
Bankfull Cross Sectional Area (ft <sup>2</sup> )	47.84				
Maximum Bankfull Depth (ft)	3.17				
Width of the Floodprone Area (ft)	38				
Bankfull Mean Depth (ft)	1.8				
Width/Depth Ratio	14.75				
Entrenchment Ratio	1.43				
Bankfull Width (ft)	26.55

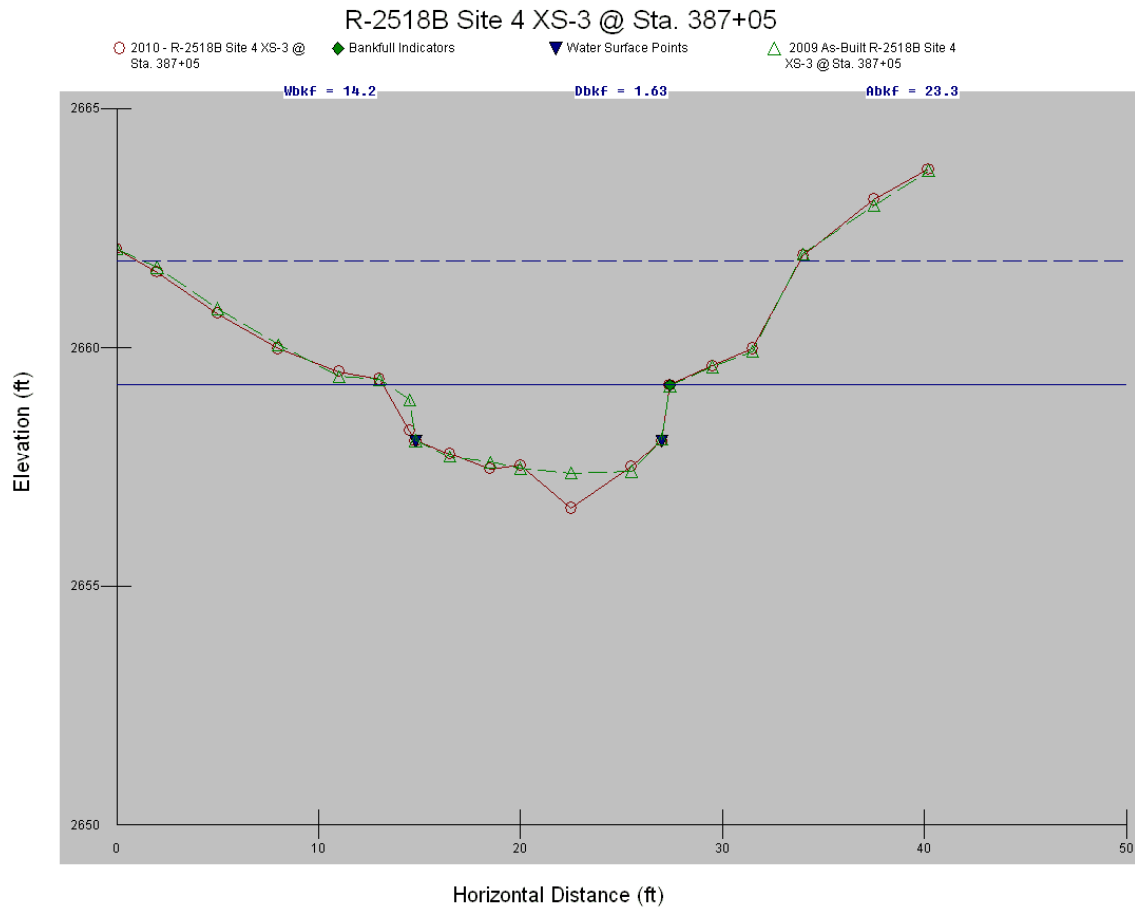
Site #4: Cross-Section #3 (Riffle) Abbreviated Morphological Summary					
	2010	2011	2012	2013	2014
Bankfull Cross Sectional Area (ft <sup>2</sup> )	23.26				
Maximum Bankfull Depth (ft)	2.6				
Width of the Floodprone Area (ft)	32.87				
Bankfull Mean Depth (ft)	1.63				
Width/Depth Ratio	8.73				
Entrenchment Ratio	2.31				
Bankfull Width (ft)	14.23

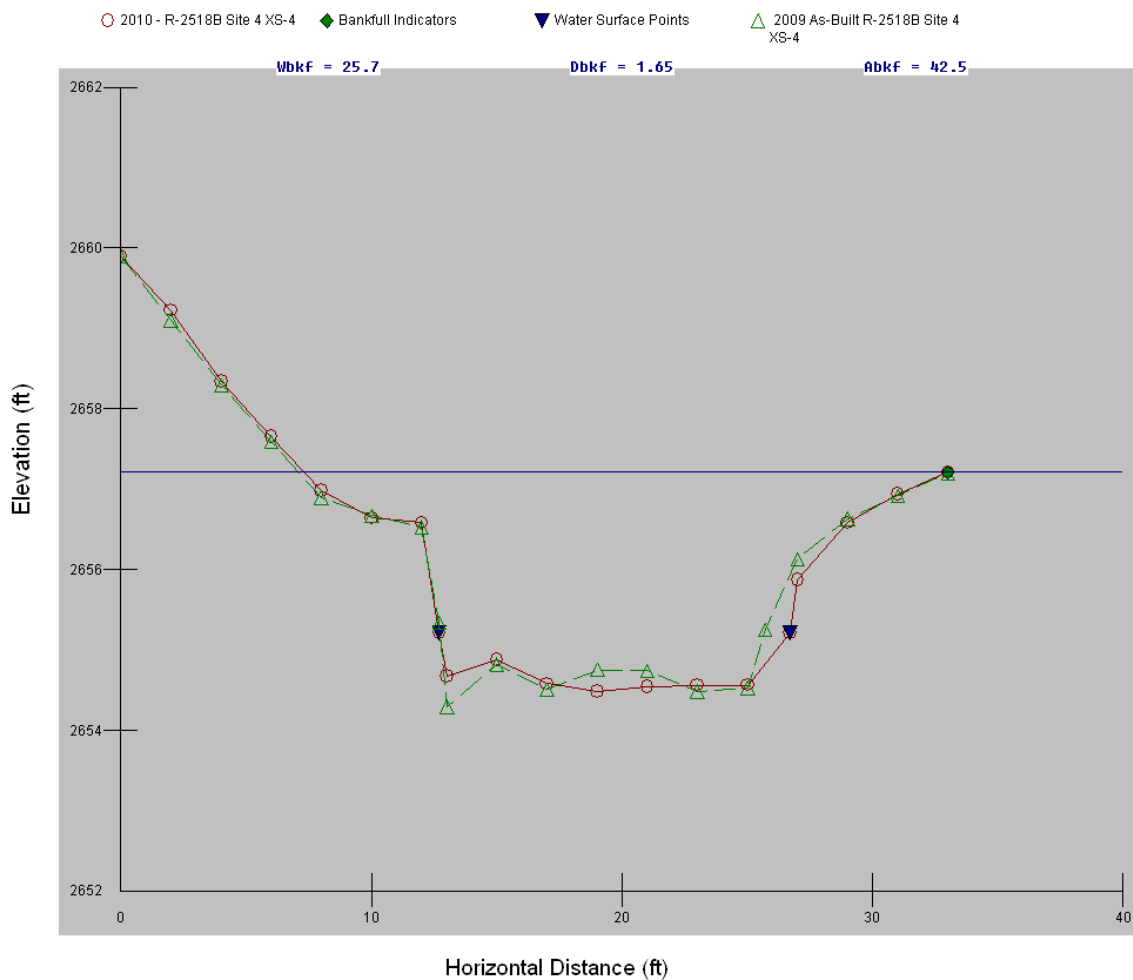
# R-2518B Site 4 XS-4

## Site #4: Cross-Section #4 (Pool) Abbreviated Morphological Summary\*

2010	2011	2012	2013	2014
Bankfull Cross Sectional Area (ft <sup>2</sup> )	42.48				
Maximum Bankfull Depth (ft)	2.73				
Bankfull Mean Depth (ft)	1.65				
Bankfull Width (ft)	25.69
